North Fume Collector Fan Failure

Date: 9/7/06

PMT Representative: D Williamson

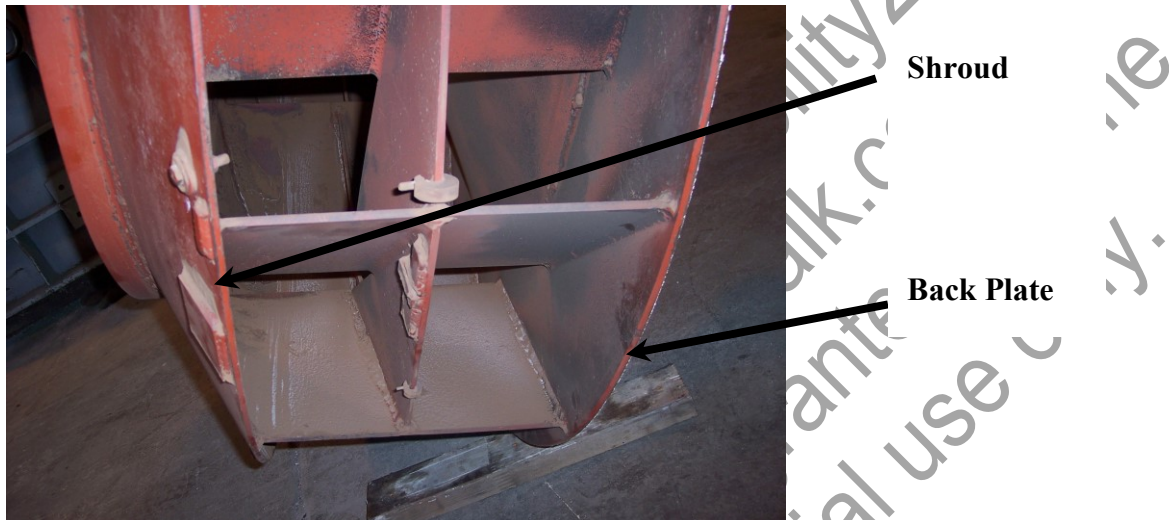
Picture #1

Impeller- The fan housing inspection doors were opened to inspect the impeller and it was obvious this has been a problem fan for a long time. The fan wheel is approximately 5 ½ ft diameter and has 3 major groupings of balance weights on it, each located about a 1/3 of the way around the impeller from the last. Then there is a

random spread of individual weights scattered about the impeller. They are mostly attached to the shroud (or front plate) with some attached to the vanes and vane stiffeners.

The balance contractor has either attempted to balance the impeller while it was dirty many times or he has been trying to balance out vibration problems that weren't balance problems. The former does not work well, the later never works. See Picture #1, it was typical all the way around.

Good balance practice dictates that balance weights be attached to the impeller back plate which has a direct connection to the shaft. If excessive unbalance weight is attached to the impeller shroud and it's spun up to RPM, the cantilevered load causes the back plate to flex. Over time it will fatigue and crack. This excessive unbalance can be from misplaced balance weights or dirt left caked on the impeller shaking off.

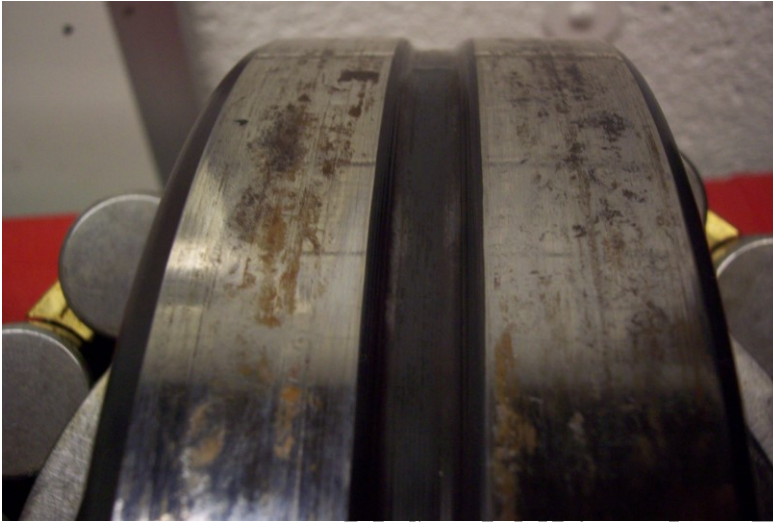
Both bearings outer races had spun in the housings and fretting corrosion was present in both housing bores. See Picture #2 of the coupling end bearing. Picture #3 is of the impeller end bearing. Clearance was measured with feeler gages and was found to be $>.004$ at the coupling end and $>.006$ at the impeller end. This is excessive clearance as it normally is about half these amounts. The bearing adapters were both mounted solidly to the shaft and had not spun on it. The coupling end bearing was set up as the fixed bearing.

Both bearings were lubricated with Permas but they had 2 types of grease mixed in them, (you can tell by the color). Delo #2 was the most recently used and is the correct grease, but the bulk of the grease in the bearings was MolyMax #2. This is not the correct grease for rolling element bearings and should never be used in them.

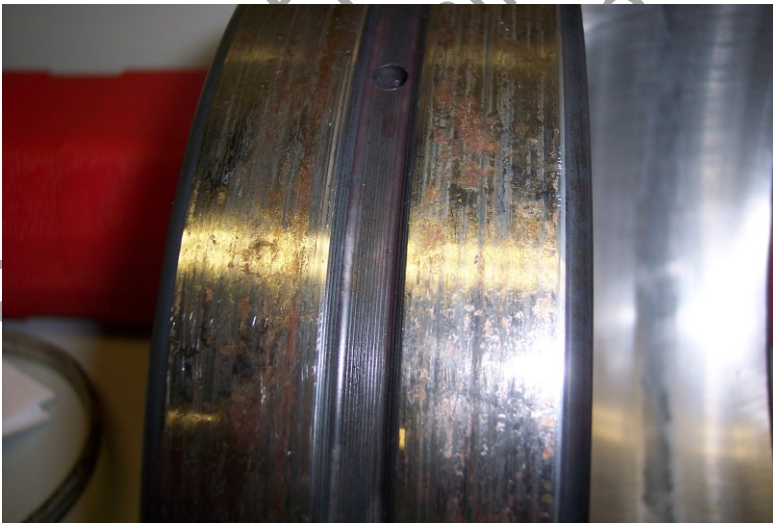
Picture #3

We observed small flecks of metal around the seal area of the impeller end bearing and so we expected to find that bearing failed, but when it was opened there was no metal flecks found inside. I believe the flecks were from misaligned aluminum labyrinth seal, rubbing on the housing under the extreme vibration.

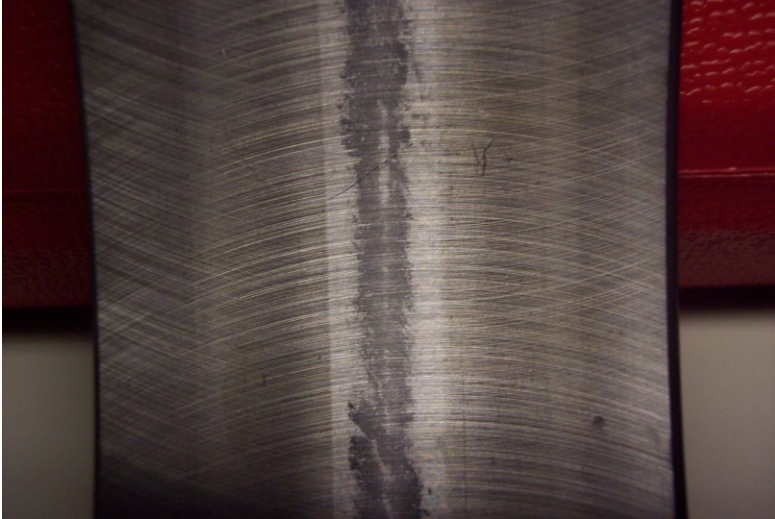
The races and rollers all appeared to still be visually in fair shape. The outer race looked new as it still had grinding marks from the manufacturing process in it. The cage was bronze and not noticeably worn. Picture #4 is the outer race on the impeller end bearing.

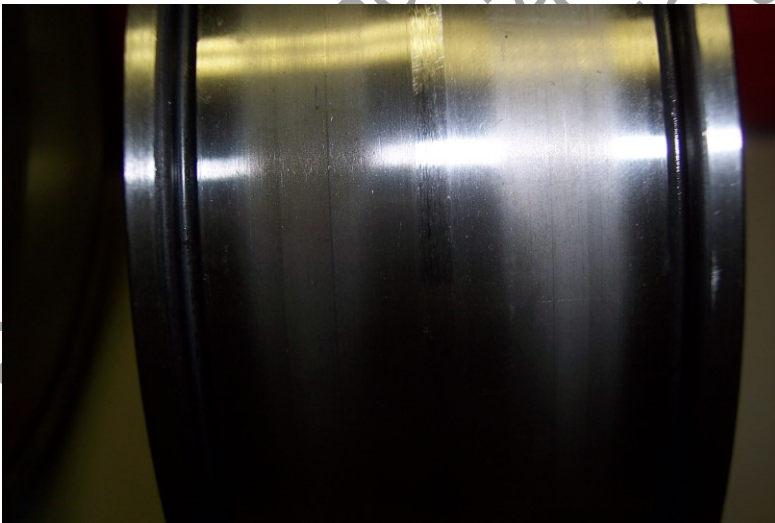
The inner race was frosted on the wear track. This is probably an indication of a lubrication issue at some time in its life. There were signs of contamination within the wear track. Picture #5 is the inner race. The small dark specs that can barely be seen on the inner race picture are the result of contamination embedding in the bearing race.

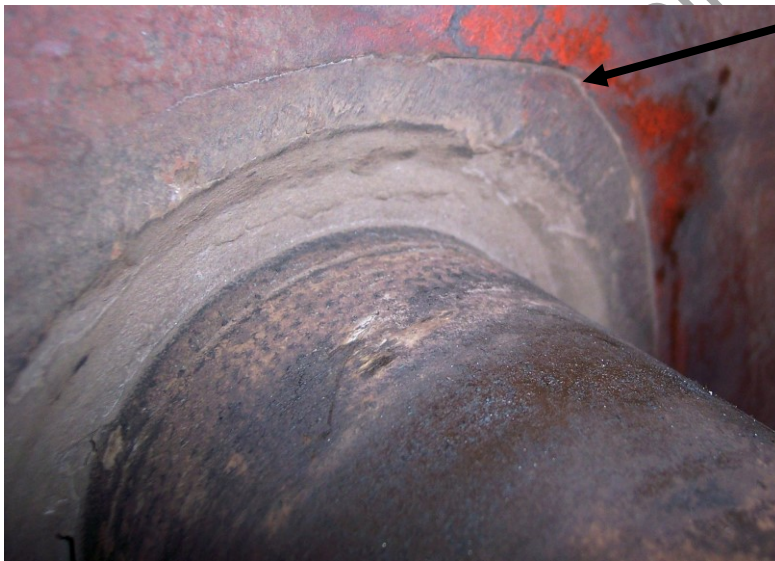
Picture #5

We decided to remove the quarter panel to check the fit better. Even if the fit was found to be good, removing the quarter panel would make installing the new bearings much easier. With the quarter panel removed we were able to see a crack in the impeller back plate about $\frac{1}{2}$ way around the shaft. See Picture #5. This crack is about 1 $\frac{1}{2}$ " out from the shaft and in the area where the hub was welded to the back plate.

I can't say for sure that all those balance weights that were welded to the shroud caused this crack, but those weights were generating forces that would have been trying to flex the back plate in this manner. The flexing of the back plate is most likely the driver of the .9 IPS axial vibration.

A new wheel and shaft was ordered to replace this failed rotor. The shaft is to be 1045 Turned Ground & Polished or better, +.000 -.003. Balance spec is G2.5 or better.
